# Will-Burt Product Service Bulletin

## Expedition Mast Product Line

Base Plate Fractures and Breaks

Bulletin # 0105

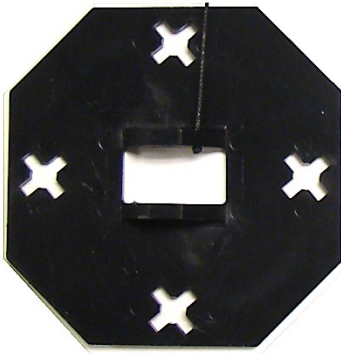
Figure 1: “X” Pattern

Some Expedition masts shipped between 12/12/08 and 9/1/11 have base plates made of a more rigid material, which is less tolerant of improper stake installation, which can result in cracking, chipping or fracturing of the base plate. This could affect the stability of the tripod. All base plates within these dates and with the “X” hole pattern, shown in Figure 1, have this potential problem. Figure 2 shows the new style base plate, which does not have the potential problem.

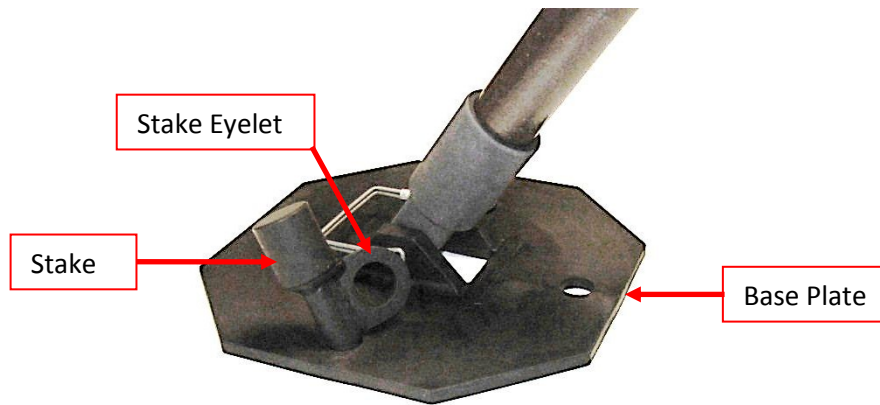
Figure 3: New Style Base Plate with Proper Stake Orientation

Improperly positioning the stake eyelet, or over-driving the stake, may cause a base plate to fracture. Figure 3 shows the proper positioning of the stake eyelet.

- Ensure proper orientation of the stake eyelet (towards the tripod leg).
- Do not drive the stake eyelet through the base plate. The stake eyelet should be flush or just above the base plate.
- Replace base plate(s) if damaged.
